# Manhole Inspection Summary

Manhole # S19I\_\_045MH

Insp Date: **9/28/07 11:11 AM**

**Location** Address: **2000 FREDERICK AVE**

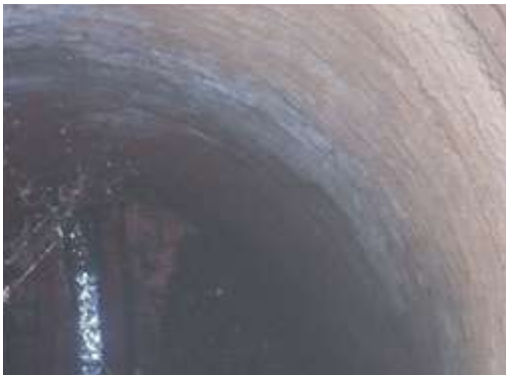
Defect 3

Infiltration: ☐ None ☒ **Joint** ☐ Cracks ☐ Mortar ☐ Roots ☐ Wall

BARREL INFILTRATION

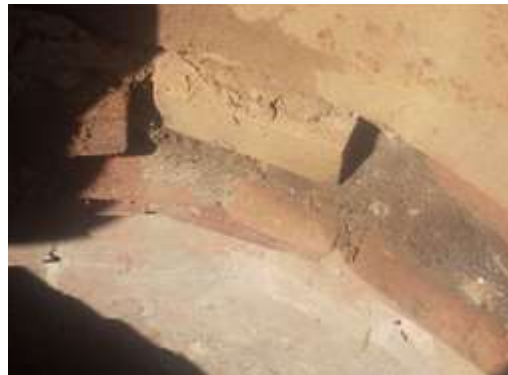
Defect 2

Condition: ☐ Sound ☐ Cracked ☐ Root Intrusion ☒ **Loose Brick** ☐ Deteriorated

LOOSE CHIMNEY BRICKS

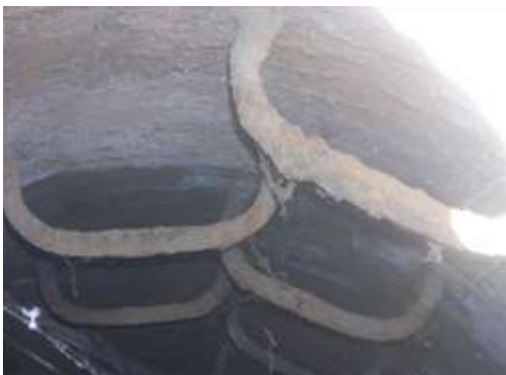
Defect 1

Count: **6** Missing: **0** ☒ **Corroded**

CORRODED STEPS

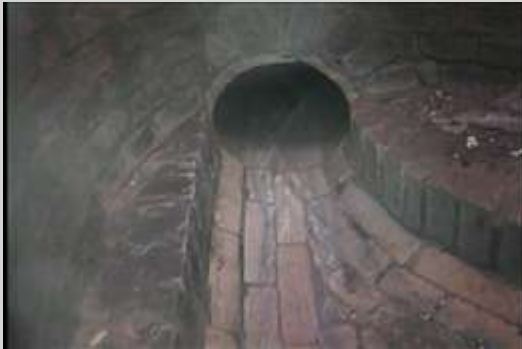
12 O'Clock Outflow

10 in. Circular Gravity Sewer  
Pipe Out @ 12 O'Clock

Pipe Height: **9.6** (in.) Rod and Bar (Angled)  
Pipe Material: **Clay** ☐ Pipe Lined  
Invert Depth: **10.44** (ft.) Flow Characteristics: **Slow**  
Deposits: ☒ None ☐ Mud ☐ Sludge ☐ Debris ☐ Grease  
Silt Depth: (in.) Deposits Extent:  
Infiltration: **None** Pipe Seal Cond: **Sound**

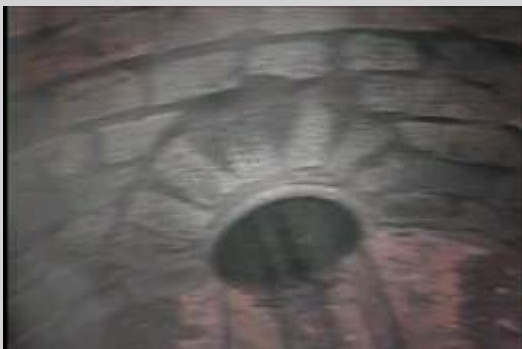
4 O'Clock Inflow

8 in. Circular Gravity Sewer  
Pipe In @ 4 O'Clock

Pipe Height: **8.4** (in.) Rod and Bar (Angled)  
Pipe Material: **Clay** ☐ Pipe Lined  
Invert Depth: **10.05** (ft.) Flow Characteristics: **Slow**  
Deposits: ☒ None ☐ Mud ☐ Sludge ☐ Debris ☐ Grease  
Silt Depth: (in.) Deposits Extent:  
Infiltration: **None** Pipe Seal Cond: **Sound**

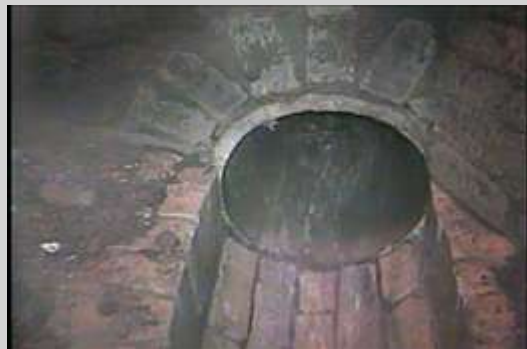
6 O'Clock Inflow

10 in. Circular Gravity Sewer  
Pipe In @ 6 O'Clock

Infiltration: **None** Pipe Seal Cond: **Sound**
